Monitoring Data Record

Project Title: R-2214A COE Action ID: 200330312
 Stream Name: Mud Creek Tributary (Site 3) DWQ Number: 011715
 City, County and other Location Information: Intersection of US 25 and Industrial Park Rd. in Hendersonville, NC
 Date Construction Completed: March 2005 Monitoring Year: (2) of 5
 Ecoregion: _____ 8 digit HUC unit: 06010105
 USGS Quad Name and Coordinates: _____

Year 2 – February 2007

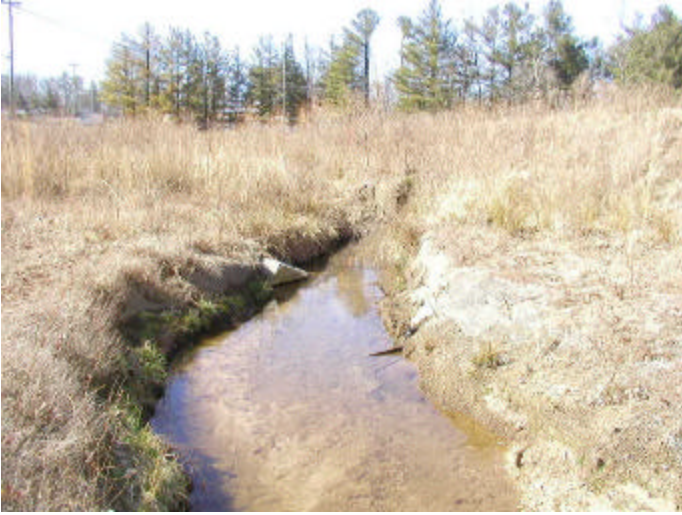
Photo 7 (Upstream)

The Mud Creek Tributary is stabilized for the Year 2 Winter evaluation. Some minor bank erosion was noted on the left bank (Photo 7 – Upstream). The lower portion of the stream that was reconstructed to have a better tie-in with the existing channel has been replanted. NCDOT will continue to monitor this stream relocation.
